PLAYHAVEN FARM LLC & GREEN BUILDING PROJECT

GREENOVATION : FIREPLACE CHIMNEY

EXTERIOR CHIMNEY REPAIR (SEPTEMBER 2008)

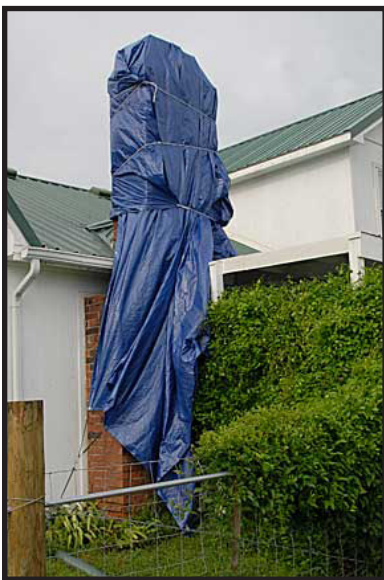
Tarped to minimize water seepage to basement.

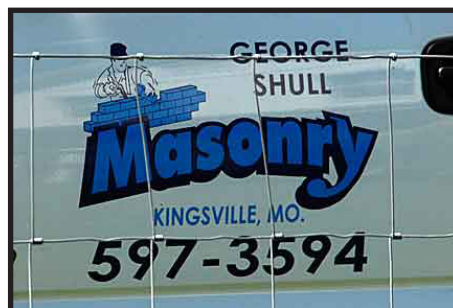
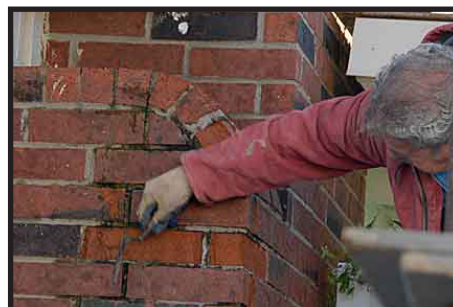
Removing the bad brick.

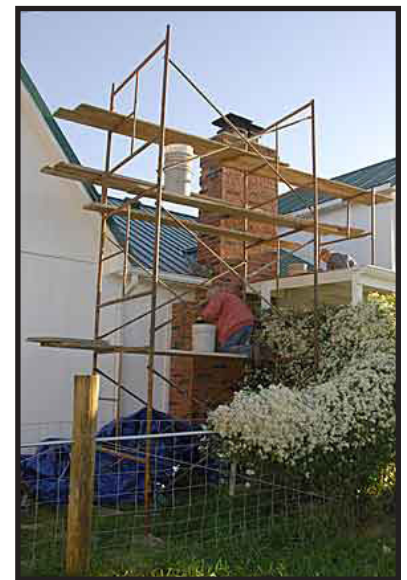
The scaffold goes up and the flakes come off.

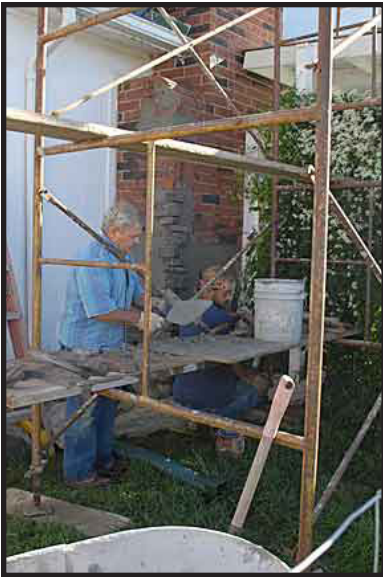
After patching, the corners start the process.

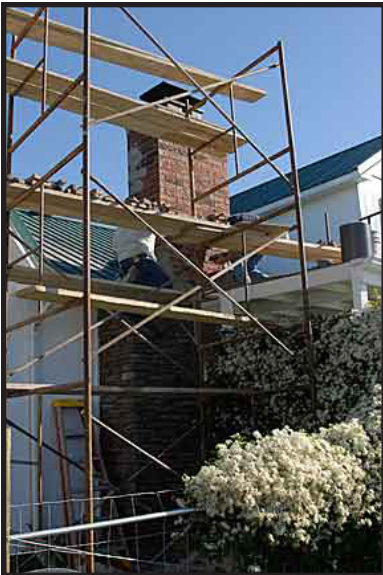
Putting in the flashing.

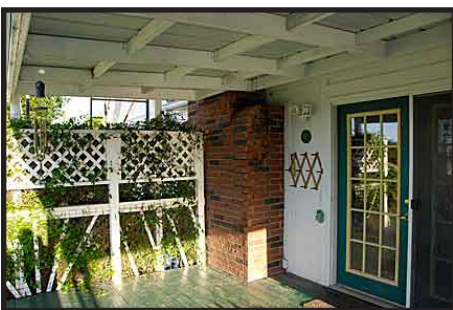
The part under the deck roof - before.

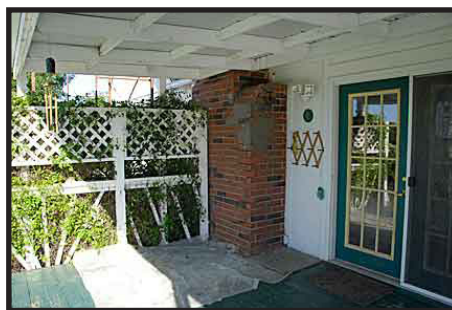
.... now patched.

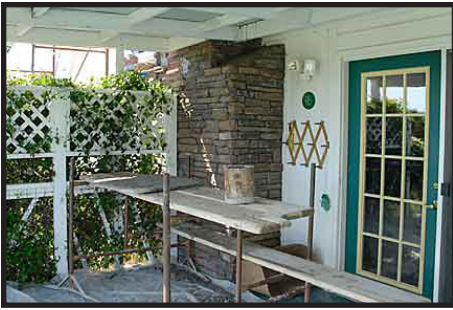
.... capstone in place.

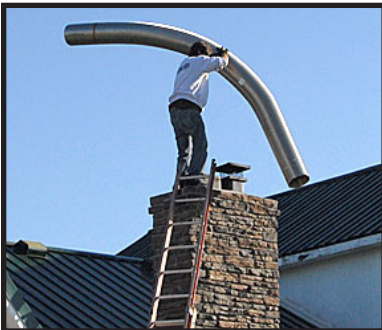
Getting the Liner into the Chimney

(there is a second chimney for the basement wood stove that you see to the right of where the new liner is being inserted)

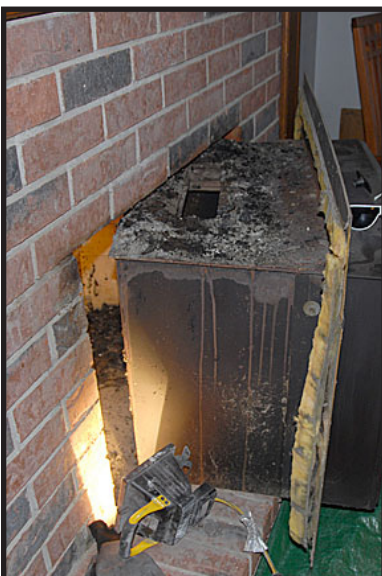
Looks like the chimney hasn't been cleaned for a really long time... that is creosote on the wood stove insert.

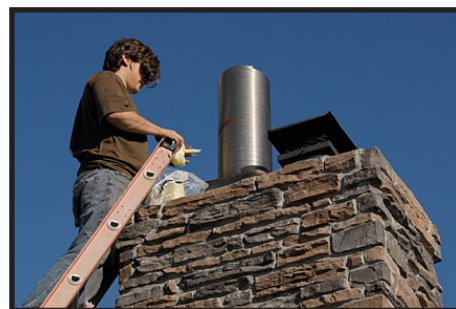
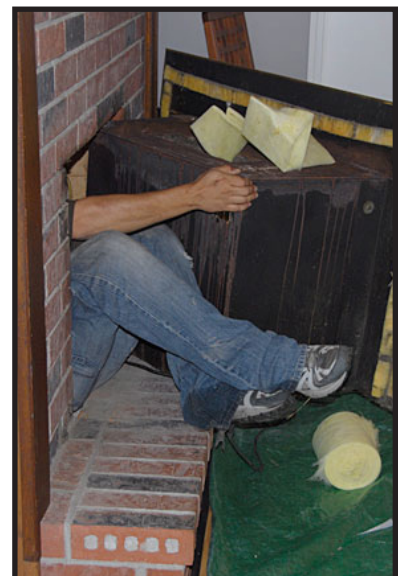
They put fiberglass insulation at strategic points to hold the liner in the center so they can pour the mortar-like insulation around it... at the top and at the bottom (see picture at right).

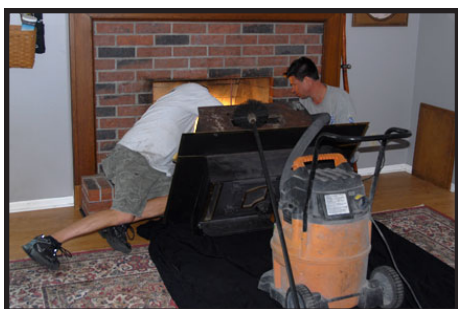
Making sure the mortar-like insulation doesn't come through at the bottom and then cleaning up with the super vacuum.

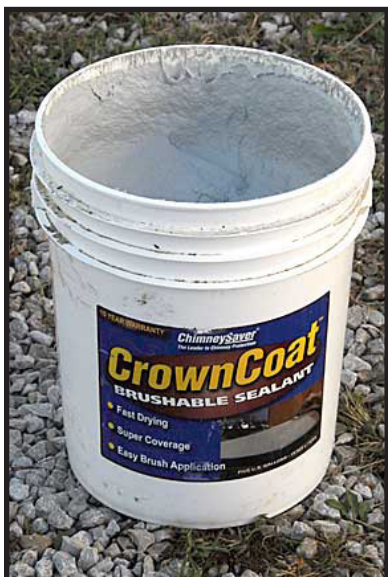
It ended up that we complicating things a bit because we had the architectural stone applied before the liner.

They thought about cutting into the exterior to do what they needed to to keep the mortar-like insulation from going into the hearth area. But instead, they were able to do what they needed from inside the hearth area itself.

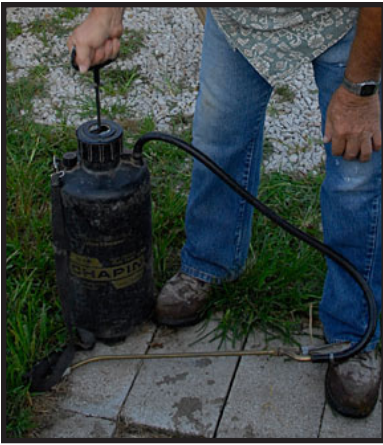
Brandon got the job of spraying. Here is George pumping up the sprayer. I liked the fact that they used the pump sprayer as opposed to something that would use fossil fuels.

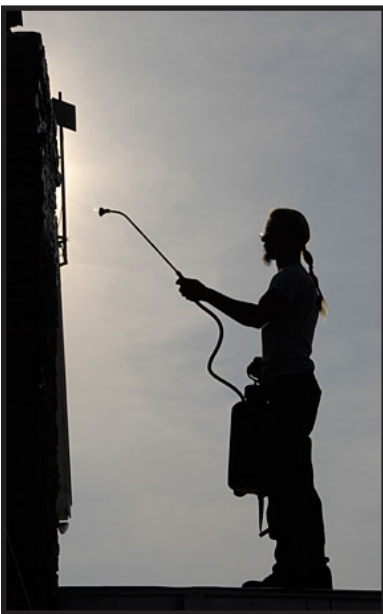
This image gives a nice contrast between the treated stone and the untreated stone. The darker areas are treated and the color is still nice and vibrant even though it has cured.
